1.0 Purpose

The purpose of this report is to provide a record of the performance of the CSD (Crew Systems Division) furnished equipment during the Apollo 11 mission. This report will include preflight, inflight, and post-flight problems, activities, and performance.

2.0 Apollo 11 EMU Hardware and Crew Provisions GFE (Government-furnished equipment)

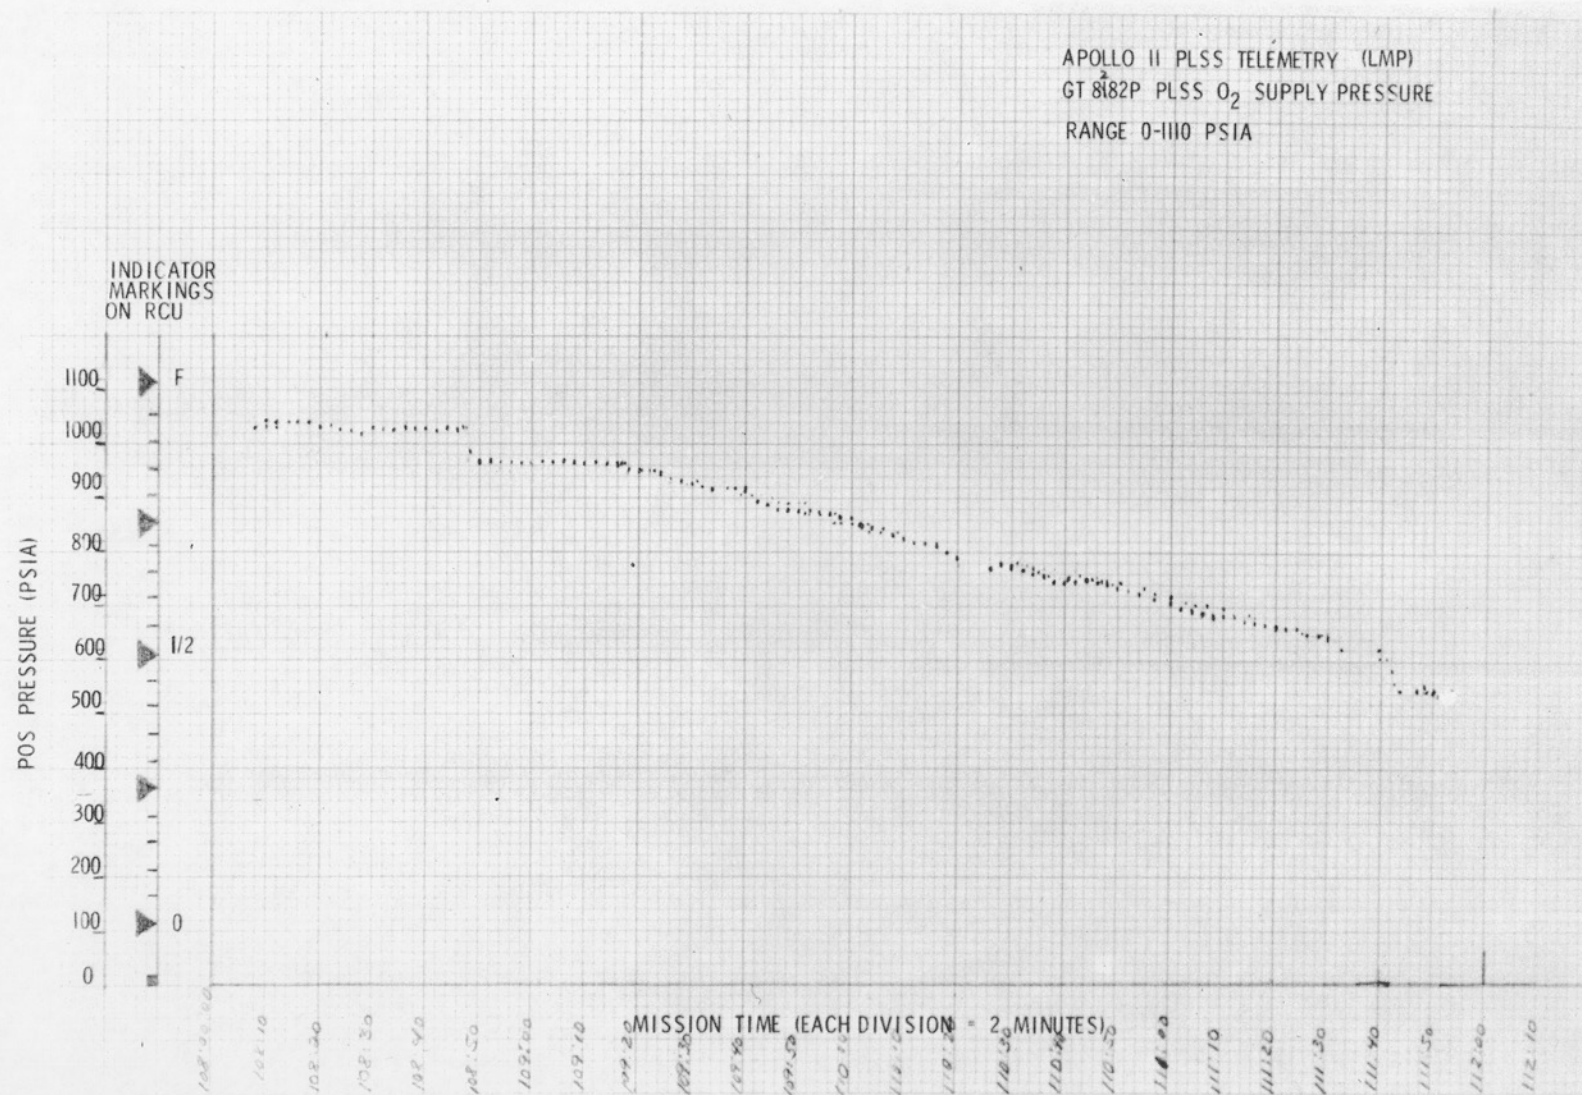
was 1020 psia from both PLSS's (See Figure 1 and Figure 2). This compares favorably to the preflight 1024.7 psia for PLSS S/N 00014 and 1022 psia for PLSS S/N 00015. Communications broke up several times during PLSS checkout. At the time it was thought to be due to PLSS antenna position, however, it was determined by the crew that the condition would occur regardless of antenna position. The problem was not a serious one but is presently under investigation by SESD. Preliminary results indicate the possibility of an improperly set LM VOX sensitivity switch causing the disturbance. All warning tones and flags were normal, all telemetry channels indicated properly and current and voltage values were nominal for this mode.
